Intel[®] Mobile Celeron[™] Processor Specification Update

Release Date: December 1999

Order Number: 244444-010

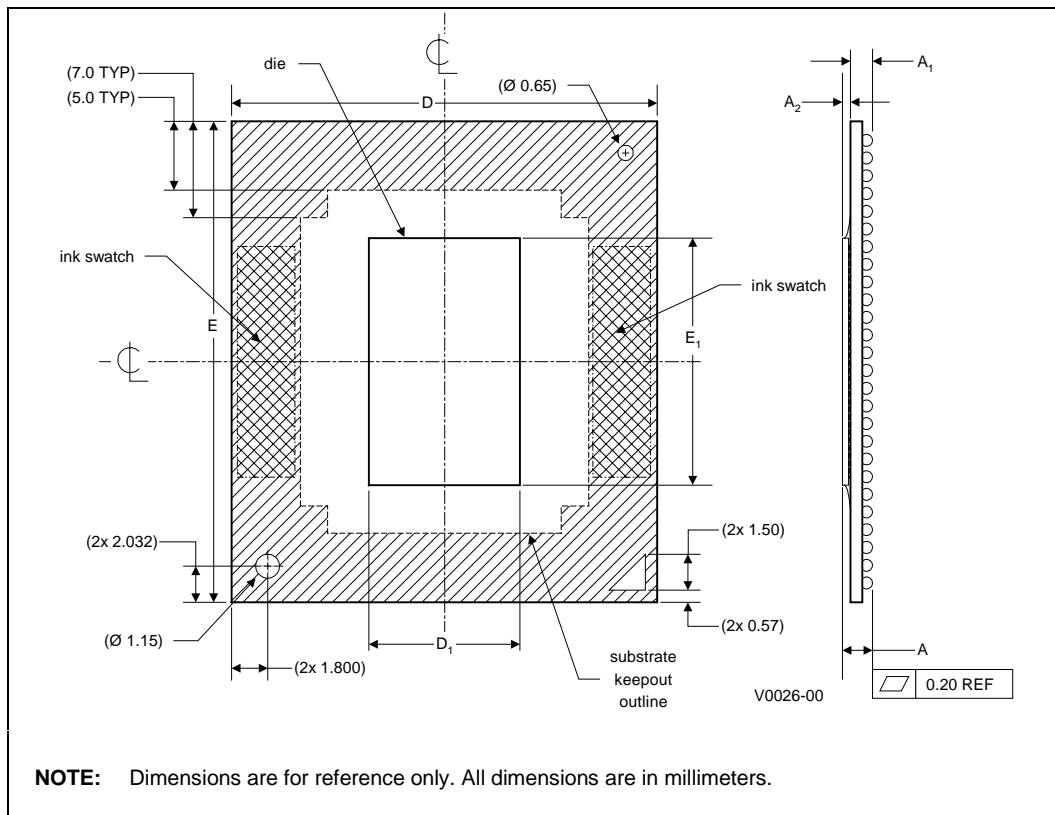
Figure 5.3. Surface-Mount BGA1 Package—Top and Side View

The following table and figures show the updated mechanical specifications for the BGA1 package, listed as Table 5.2, Figure 5.3 and 5.4, respectively, in the *Intel® Mobile Celeron™ Processor in BGA Package at 333 MHz, 300 MHz and 266 MHz* datasheet.

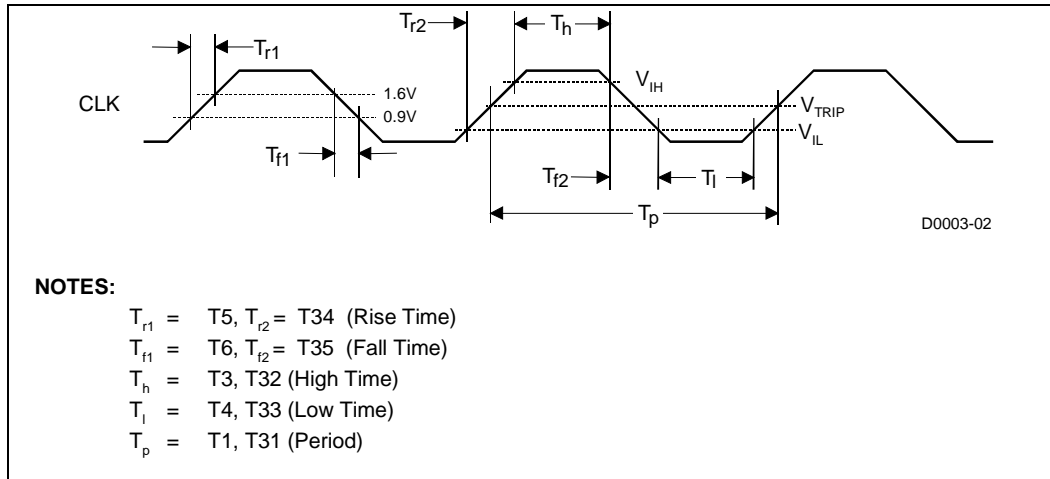
Figure 3.3 Generic Clock Waveform

H11. Generic Clock Waveform Figure

Figure 3.3 in the *Intel® Mobile Celeron™ Processor in μ PGA1 and BGA1 Packages at 366 MHz, 333 MHz, 300 MHz, and 266 MHz* datasheet (Order Number 245112-003) has been updated. The following figure is to replace the one in the above document.
